Manhole Inspection Summary

Manhole # S35WW_026MH

Insp Date: **1/9/07 10:02 AM**

Location Address: **3050 ABELL AVE**

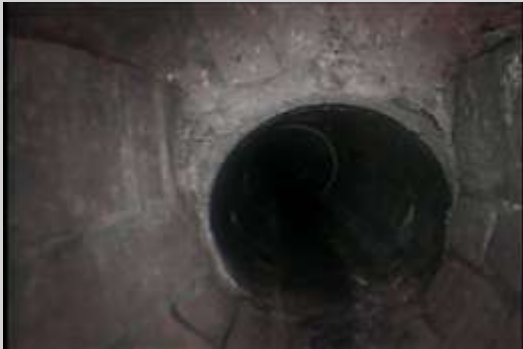
8 in. Circular Gravity Sewer Pipe Out @ 12 O'Clock

Rod and Bar (Angled)

Pipe Material: **Clay** ☐ Pipe Lined

Infiltration: **None** Pipe Seal Cond: **Unknown**
